ROOF DISCOVERY REPORT

Facility: Faith United Church of Christ
575 Richmond Road
Richmond Heights, Ohio 44143

Subject: Steep Slope Roof Evaluation

Date of Inspection: June 11, 2013

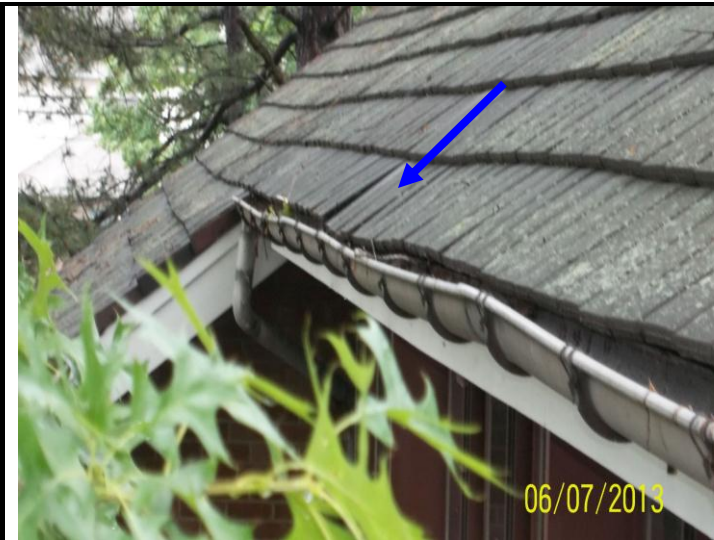
- Roof Deck: On the Sanctuary there is an area that the steep slope wood deck has started to rot. This area is not widespread but should be addressed as soon as possible.
- Soffit: The soffit at the preschool is in fair condition however, the bird and insect screen that is used for venting has dry rotted allowing birds to enter the soffit/attic space.
- Entrance/Parlor: The modified bitumen roof system is in fair condition. It appears that the entrance was added to the Parlor area at a later date. There is a large amount of ponding water which should be addressed. If this is not corrected the roof membrane will deteriorate and no longer provide weather protection.
- Basement Stairwell: This area is prone to retaining a large amount of water due to run off of two roof areas draining into an undersized gutter and lack of a properly installed diverter at that area.

Photo 1 – Area of rotted wood deck on Sanctuary roof.

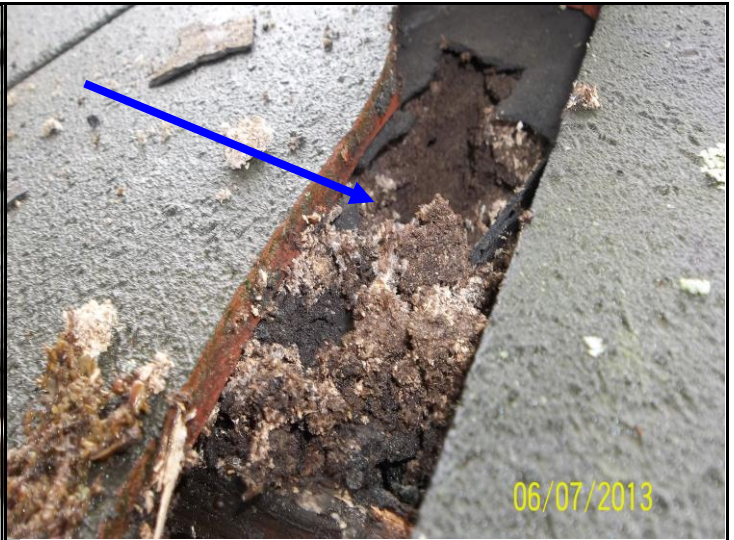
Photo 1 – Rotted wood deck. Cement tile has split with lack of deck support.

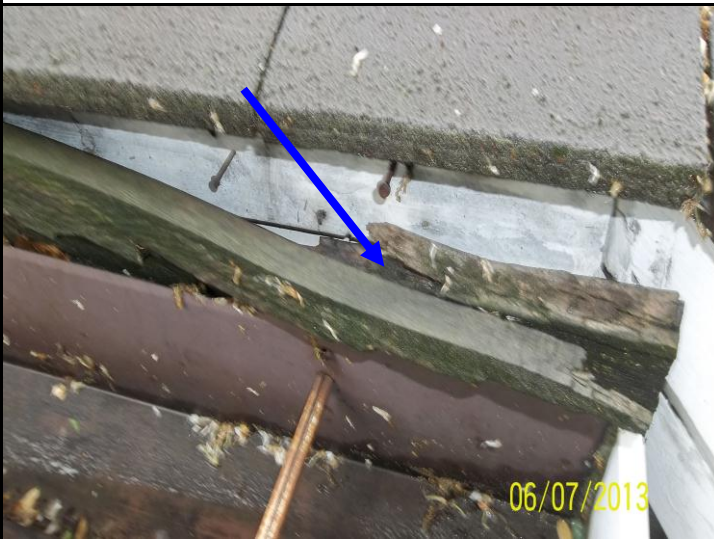
has resulted in multiple areas of the fascia board becoming rotted and not being able to support the gutter in a manner as to allow for proper drainage of rain water. The displacement of the gutter has also created a condition where water is wicking back to the soffit allowing the soffit to become damaged.

Photo 2 – Fascia board that has rotted and no longer can support the gutter. The gutter is severely dislodged from fascia board.

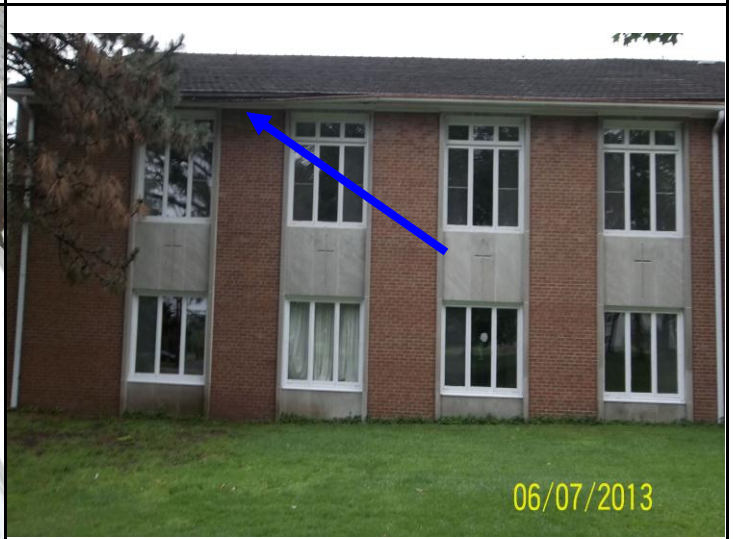
Photo 4- Fascia board has rotted and can no longer support the gutter.

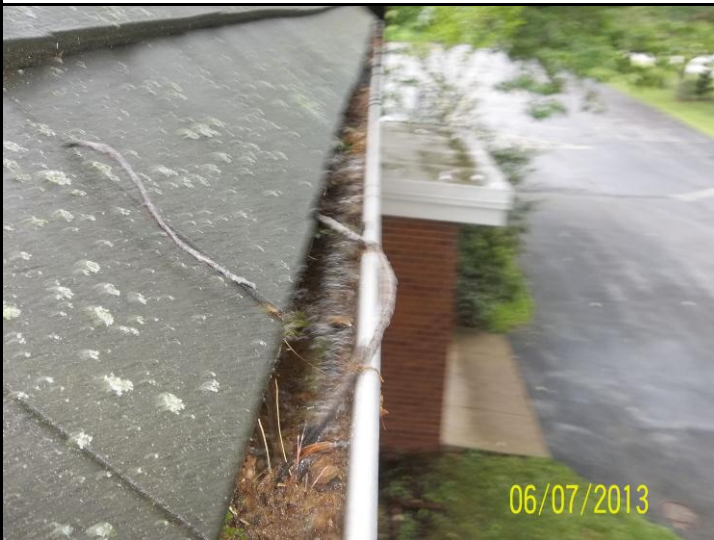
Photo 3 – Gutters are filled with debris and not draining properly.

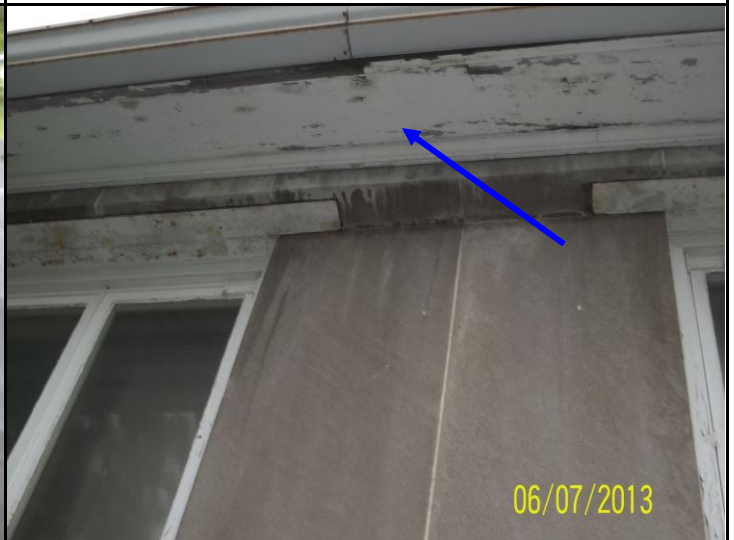
Photo 4 – Soffit with deterioration. This board should be replaced with the roofing project.
